Monitoring Data Record

Project Title: U-2524AC Site 1 COE Action ID: 200321137

Stream Name: UT No. 9 to Bull Run DWQ Number: 030909

Year 3 Winter – January 2008

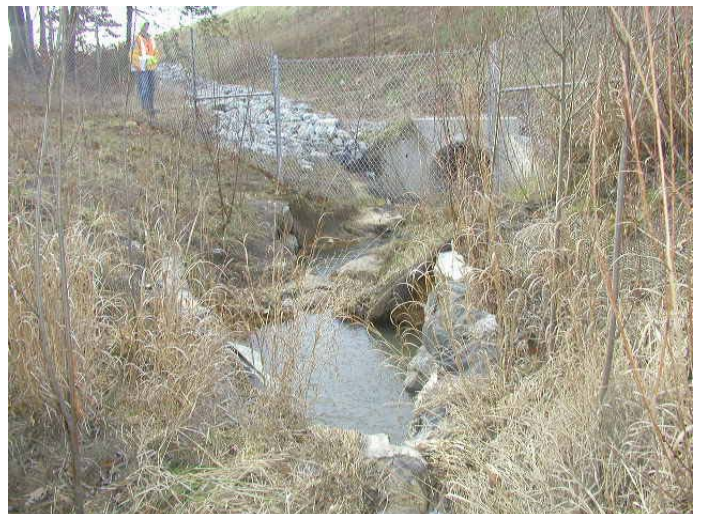
Photo Point #3 (Downstream)

This is the Year 3 winter evaluation of this stream relocation. The stream is stabilized at this time. Some minor bank erosion still exist below a crossvane (Photo Point #3 Downstream) but is not affecting the overall stability of the stream relocation. NCDOT will continue to monitor this stream relocation.

1/16/08	Sta. 58+20-L-	Station Number	Station Number	Station Number	Station Number
Structure Type					
Is water piping through or around structure?					
Head cut or down cut present?					
Bank or scour erosion present?	Minor bank erosion
